Moving down or not?

PHASE II: Yara

Water supply related technical support for the in-situ adaptation of Yara to the water crisis

February 2014

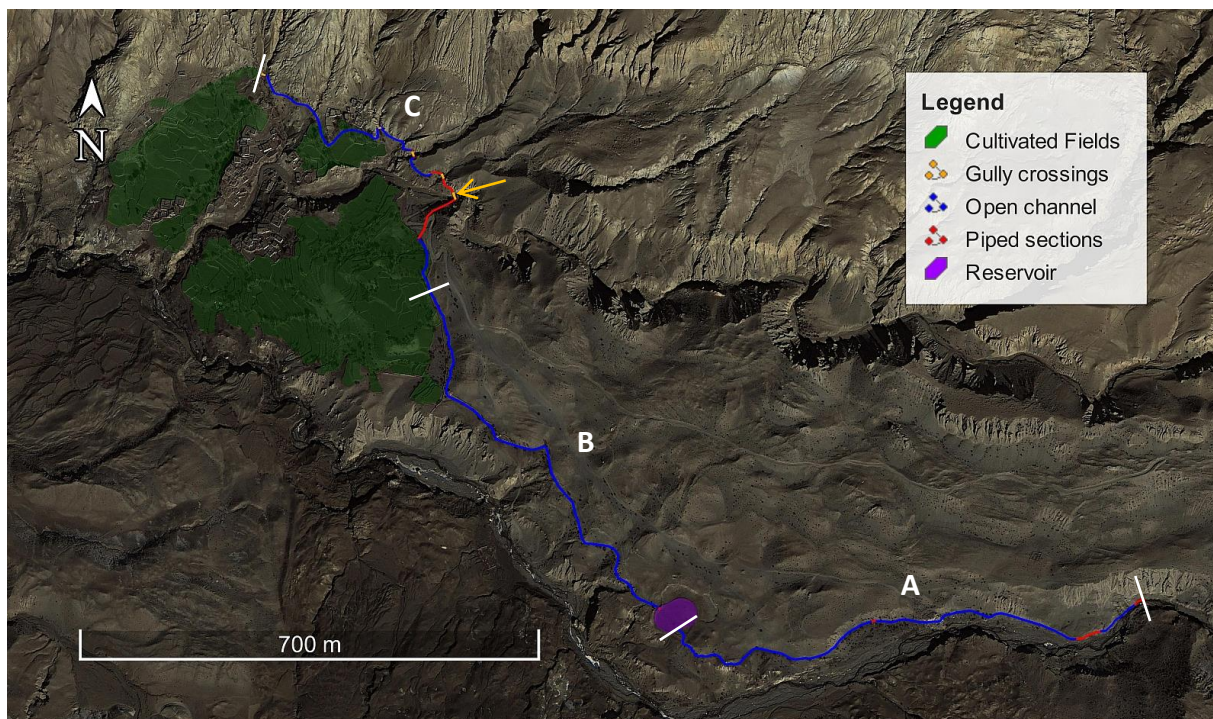
The irrigation water supply system consists of an open channel, whereof few short sections are piped (Figure 3.1). To cross five different-sized gullies different structures were built. Shortly before the field work in Yara at the end of September 2013, the largest of these crossings collapsed (orange arrow, Figure 3.1) and needs repair (Appendix A.5).

Figure 3.1: Current irrigation water supply system. The water is abstracted from the Puyung Khola, brought to the reservoir and distributed by obstructing the open channel at certain places to direct the water to the desired fields. The system is structured into three legs delineated by the white lines, namely the abstraction (A) and, related to the trench dividing the village, the distribution channel to the village's left (B) and the right side (C). The orange arrow highlights the inactivated gorge crossing (source: Google Earth Pro, accessed 28/01/2014).

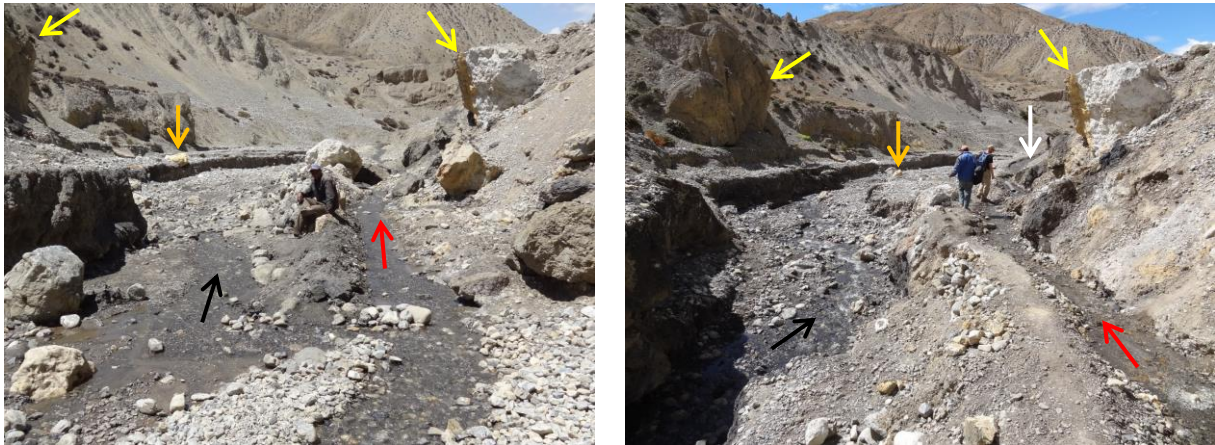
The Puyung Khola exhibits eroding tendencies (Figure 3.2) posing a major challenge regarding the abstraction of the water. Building rigid structures into the dynamic river is not recommended. Due to high flow conditions and floods during the monsoon season, rigid structures are easily damaged or even washed away. Therefore, a flexible solution, adaptable to the changing riverbed, is required.

*Figure 3.2: There are indications that Puyung Khola's riverbed is eroding. The yellow arrows highlight characteristic points which can be identified easily in both pictures. The orange arrows indicate a large rock (left), which fell into the riverbed (right), as the riverbank underneath was eroded. **Left:** The abstraction as of May 2012 (photo: 11/05/2012, Daniel Bernet). **Right:** Sixteen months later, the abstracted water (red arrow) is clearly situated at a higher level relative to the flowing water in the Puyung Khola (black arrow). The proposed safe location for the pipeline's intake structure is indicated by a white arrow (photo: 26/09/2013, Daniel Bernet).*

Roughly thirty meters downstream of the place depicted in Figure 3.2, the valley opens up slightly. The right riverbank is not directly exposed to possible erosion from uphill and can be protected from erosion caused by the Puyung Khola. Upstream, the valley becomes narrower and the slopes on both sides are unstable and geologically active (Figure 3.3). Therefore, the intake structure, connecting the pipeline's first leg with the mobile water abstraction, is suggested to be located at the location highlighted in Figure 3.2 (right, white arrow).

The flexible abstraction, which needs to be roughly sixty meters long, as of September 2013, is suggested to be designed with light, flexible, removable pipes. For instance, two parallel Polyvinyl Chlorid (PVC) pipelines, often used in drainage systems, each with an outer diameter (OD) of 110 mm (4"), might be installed. These pipes are light, can be joined dryly for the given purpose and consequently, can also be removed quickly in the case of need. Namely, if the river's water level is high, the pipes should be removed to prevent them from being flushed away. After the flood, they can be reinstalled.

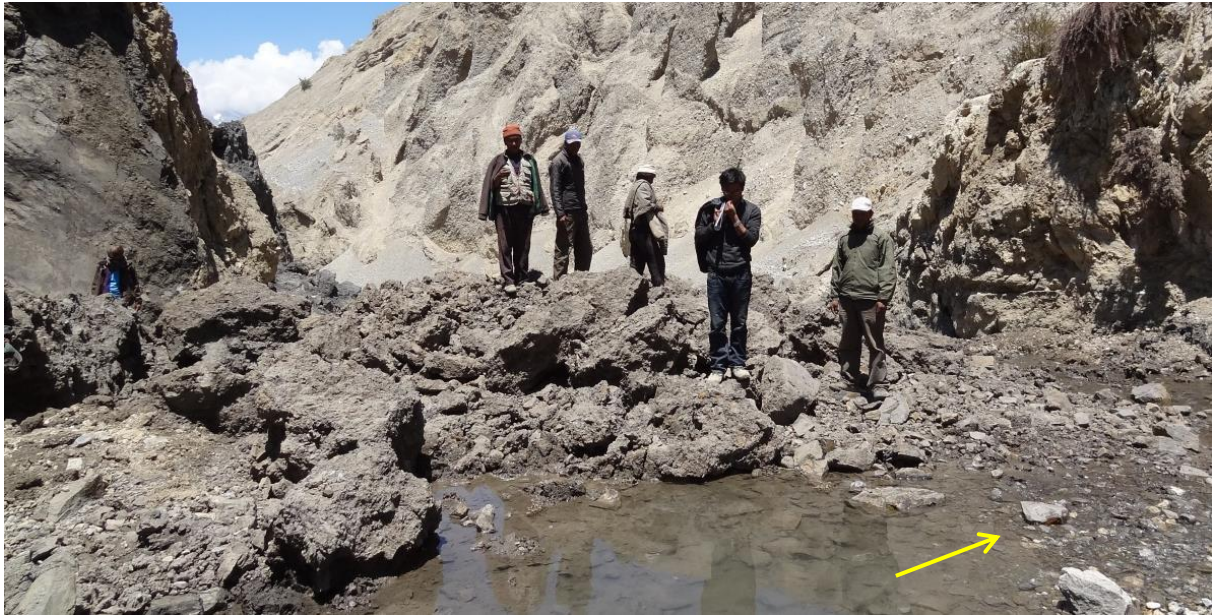
Figure 3.3: Just before the field work of Phase I, a landslide barred the Puyung Khola, roughly hundred meters upstream of the current water abstraction. A small pond was formed and the water was flowing over the deposited bar (yellow arrow). At the depicted site, as well as further upstream, the slopes on each side of the valley are unstable and geologically active. Building any rigid structure in this environment is not recommended (photo: 11/05/2012, Daniel Bernet).

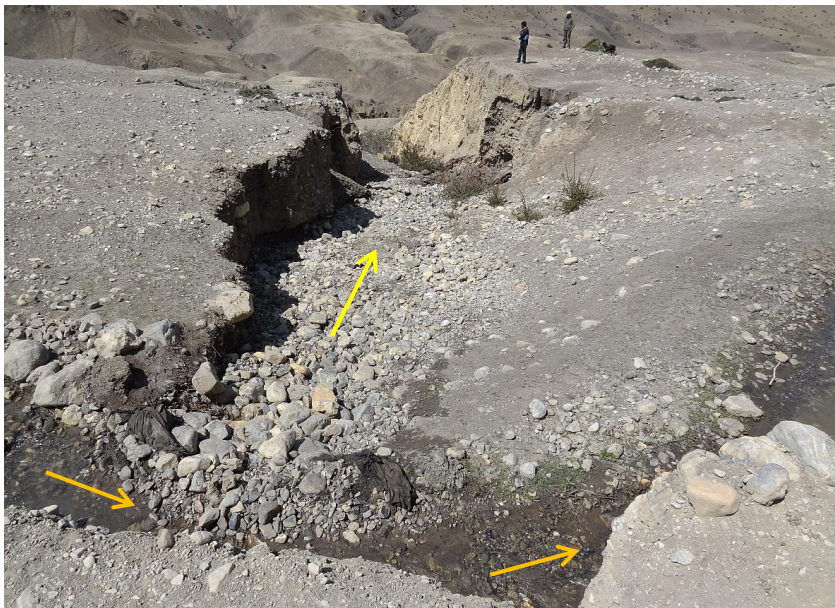
Figure 3.6: Diverting the water from the main channel (orange arrow) into a steep gorge (yellow arrow) draining into the Puyung Khola visibly led to serious backward erosion. This ongoing process has to be stopped immediately, as it is endangering the stability of the current channel and the future pipeline. Therefore, an inspection chamber accommodating a pipeline, safely conveying water back to the Puyung Khola, is proposed (photo: 11/05/2012, Daniel Bernet).

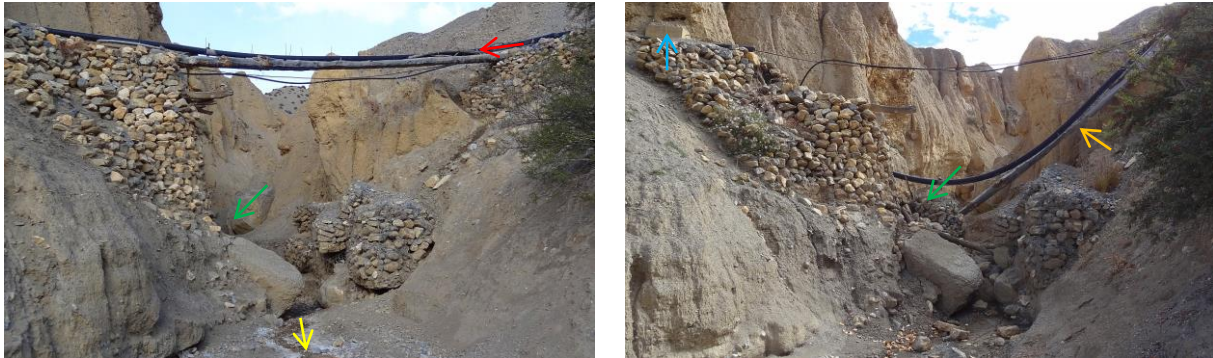
Erosion at the base of the widest crossing's structure (C1) led to the interruption of the water supply system (Figure 7.5).

Figure 7.5: Gully crossing (C1) before and after the collapse taken place in summer 2013. **Left:** The pipeline (red arrow) was fixed on a long wooden bar, which rested on stacked rocks on each side of the gully (photo: 11/05/2012, Daniel Bernet). **Right:** The base of the structure (green arrow) situated at the gully's right side (relative to the gully's flow direction indicated by the yellow arrow) was eroded, triggering the crossing's collapse. The wooden bar's right end, along with the fixed pipeline, fell into the gully, inactivating the water supply downstream. One of the two anchor blocks, holding the steel rope in place, is indicated by the blue arrow (photo: 27/09/2013, Daniel Bernet).

A proposition of how the gully crossing can be fixed is presented in Figure 7.6. It is important that the gabions are properly placed. As can be seen in Figure 7.5, the stacked rocks were merely placed on the tilted slope, which constitutes a sliding plane rather than a solid base. To place any erosion protection measure, a horizontal plane has to be excavated on which the structures can be based.

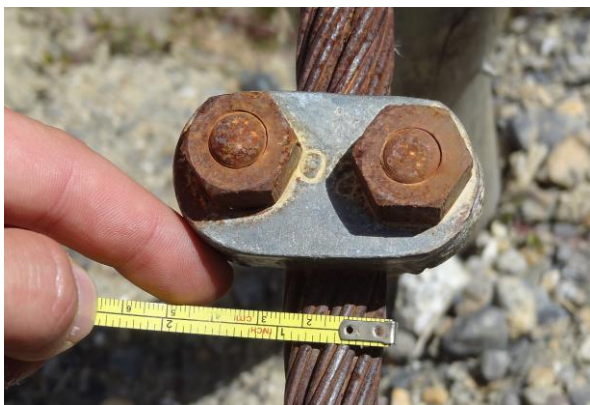
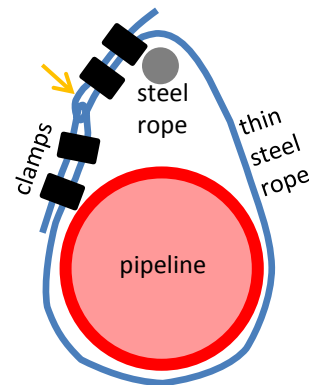
Because the used blank wire was not strong enough to carry the weight of the pipes, the pipeline could not be attached to the steel rope. To do so, iron clamps (Figure 7.7, left) and thin steel ropes should be applied, as described in Figure 7.7.

Figure 7.7: Proposed method to attach the pipeline to the steel rope. **Left:** To the anchor blocks of the crossing C1 and C3, a 25 mm steel rope is fixed. To attach the pipeline to the rope, 10 mm steel ropes and appropriate clamps, like the ones depicted in the photograph, are recommended (photo: 29/09/2013, Daniel Bernet). **Right:** cross-sectional sketch of the attachment method. First a small loop (orange arrow) at one end of the thin steel rope should be formed and fixed tightly with clamps. The rope should then be looped around the transversal steel rope and the pipeline. Following, the thin steel rope's loose end should be laced through the before created loop and tightened. The loose end should finally be looped back, fixed with clamps and the surplus rope should be cut.

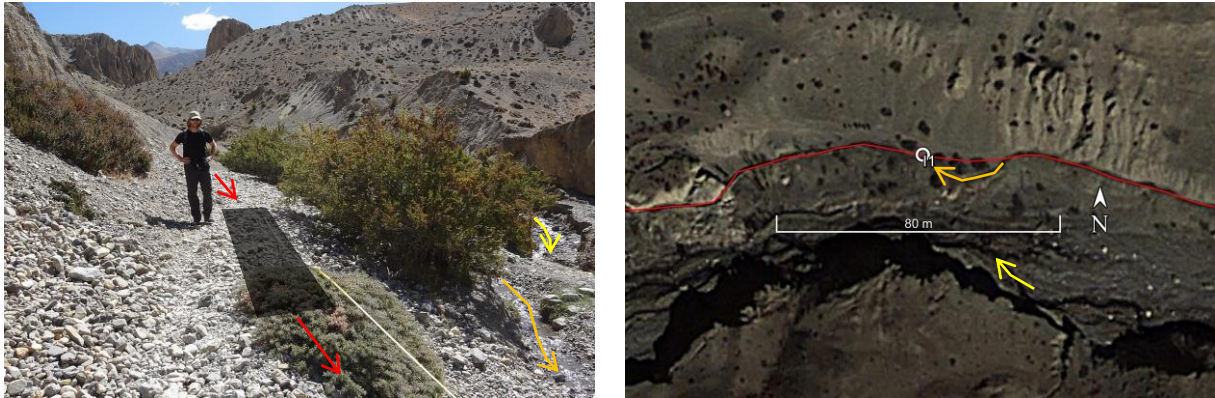
Figure 7.8: Position of the inspection chamber I1 ($x = 210$ m; $29^{\circ}05'20.66''N$ / $84^{\circ}00'38.52''E$). **Left:** Currently, the open channel runs along a cliff (orange arrow), which is destabilized by water percolating through the soil. The pipeline (red arrows) and the chamber (black rectangle) are proposed to be shifted inwards to be at a safe distance from the instable slope downhill (photo: 27/09/2013, Daniel Bernet). **Right:** Bird's eye view of the inspection chamber's location. The red line indicates the pipeline, the orange arrow highlights the current routing of the open, earthen channel and the yellow arrow points in Puyung Khola's flow direction (source: Google Earth Pro, accessed 30/01/2014).

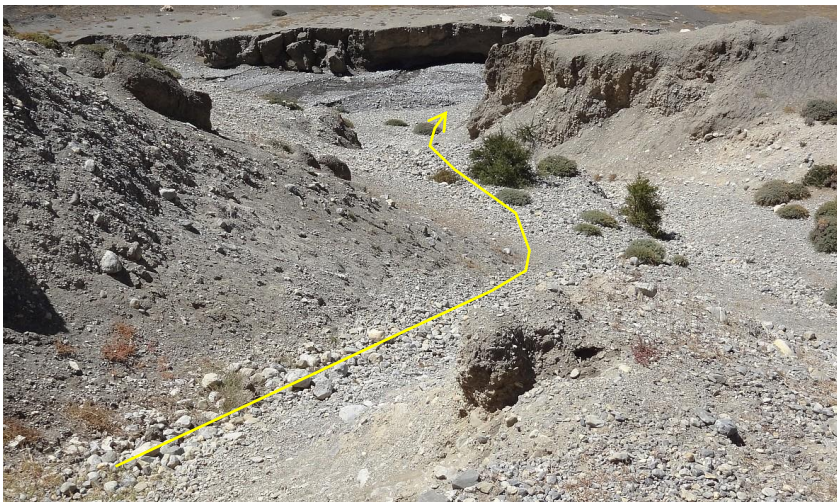
Figure 7.12: The routing of the 95 m long flush pipe connecting the inspection chamber I4 with the Puyung Khola is indicated by the yellow arrow. The installation of this pipe is important, as neglecting the safe discharge might lead to severe backward erosion endangering the stability of the future pipeline (photo: 27/09/2012, Daniel Bernet).

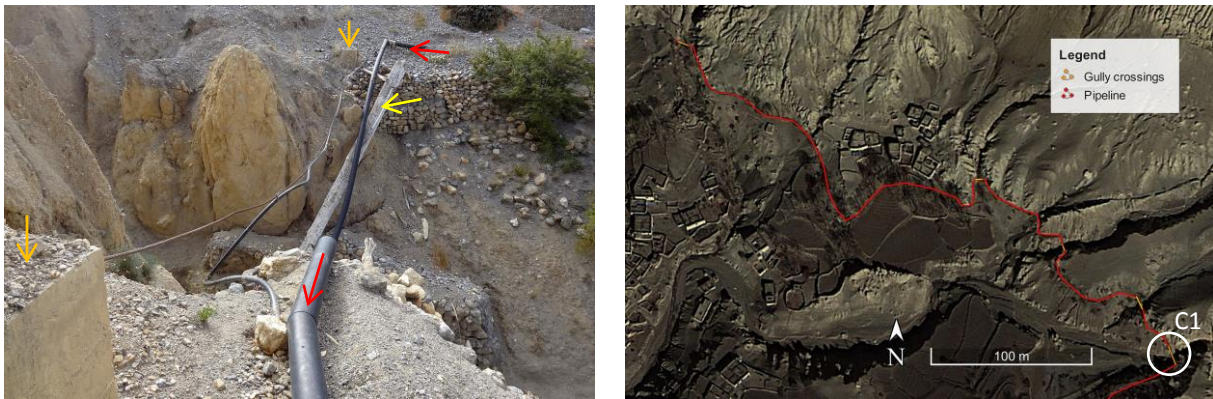
Figure 7.15: Position of the gully crossing C1 ($x = 1649 - 1666$ m; $29^{\circ}05'41.25''N / 84^{\circ}00'09.07''E$). **Left:** The pipeline (red arrow) was fixed on a long wooden bar (yellow arrow), which rested on gabion structures. The base of these gabions was eroded which triggered the crossing's collapse. On the steel rope, held by two concrete anchors (orange arrows), only the drinking pipeline was fixed, which is currently not used anymore (photo: 26/09/2013, Daniel Bernet). **Right:** Marked location of the gully crossing (source: Google Earth Pro, accessed 31/01/2014).

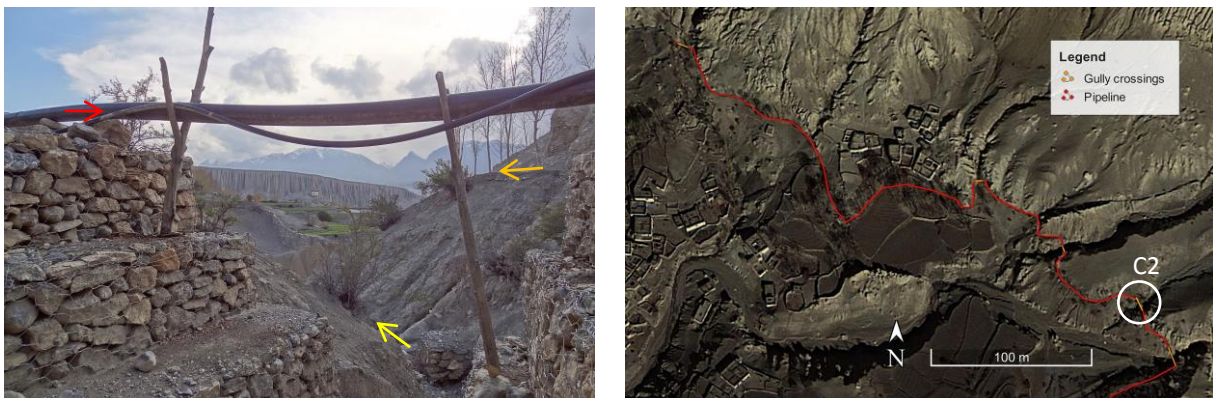
Figure 7.16: Position of the gully crossing C2 ($x = 1685 - 1698$ m; $29^{\circ}05'42.26''N / 84^{\circ}00'08.41''E$). **Left:** The pipeline (red arrow) is supported by two wooden Y-bars standing on stepped gabions on each side of the gully (yellow arrow). The open channel currently in use (orange arrow) can be seen in the background (photo: 11/05/2012, Daniel Bernet). **Right:** Marked location of the gully crossing (source: Google Earth Pro, accessed 31/01/2014).

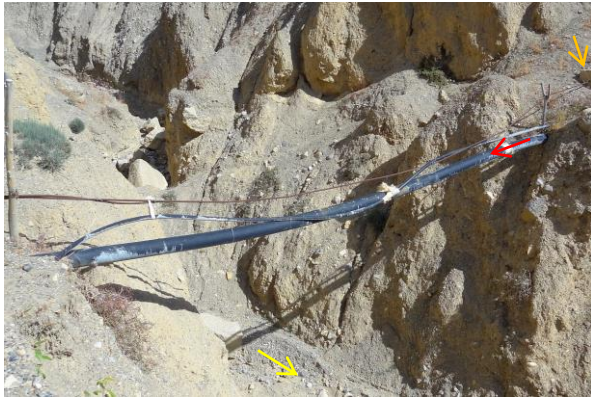
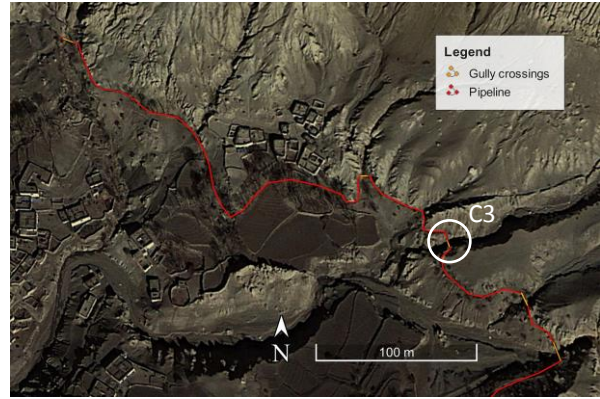
Figure 7.17: Position of the gully crossing C3 ($x = 1769 - 1781$ m; $29^{\circ}05'43.40''N / 84^{\circ}00'06.67''E$). **Left:** The pipeline (red arrow) is attached to a steel rope, held by two concrete anchors, one of which is visible (orange arrow). The flow direction within the gully is indicated by the yellow arrow (photo: 26/09/2013, Daniel Bernet). **Right:** Marked location of the gully crossing (source: Google Earth Pro, accessed 31/01/2014).

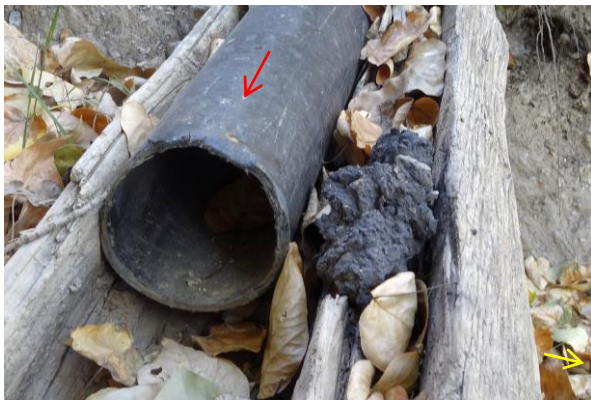
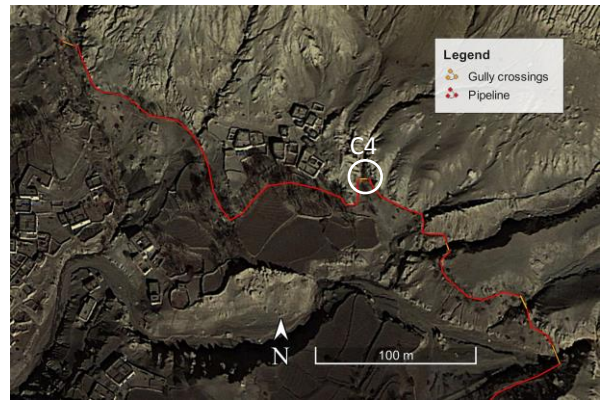
Figure 7.18: Position of the gully crossing C4 ($x = 1850 - 1854$ m; $29^{\circ}05'44.70''N / 84^{\circ}00'04.75''E$). **Left:** The pipeline (red arrow) crossing the small gully (yellow arrow) rests on a wooden bar (photo: 27/09/2013, Daniel Bernet). **Right:** Marked location of the gully crossing (source: Google Earth Pro, accessed 31/01/2014).

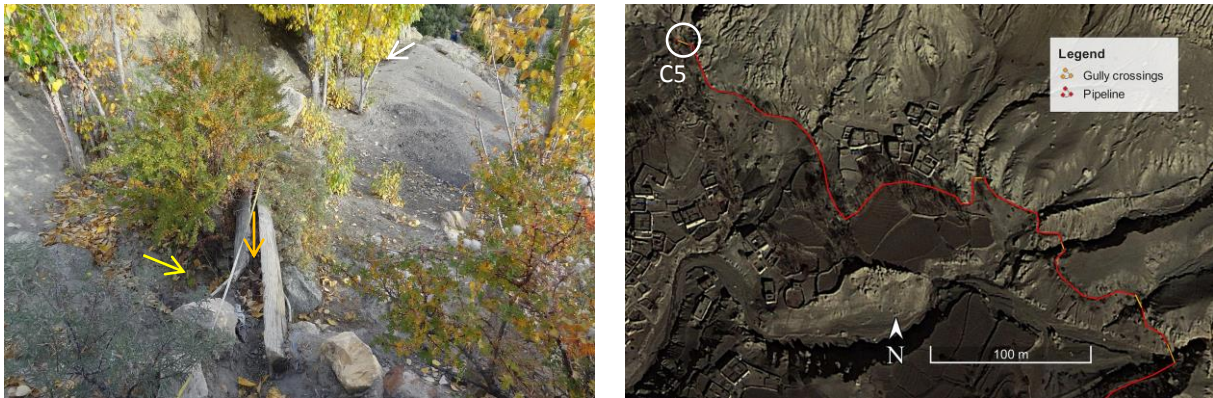
Figure 7.19: Position of the gully crossing C5 ($x = 2127 - 2134$ m; $29^{\circ}05'47.41''N / 83^{\circ}59'58.05''E$). **Left:** The open channel (white arrow) is connected to a log with a carved-in slot (orange arrow), spanning over the small gully, indicated by the yellow arrow (photo: 27/09/2013, Daniel Bernet). **Right:** Marked location of the gully crossing (source: Google Earth Pro, accessed 31/01/2014).
