Moving down or not?

PHASE II: Yara

Water supply related technical support for the in-situ adaptation of Yara to the water crisis

February 2014

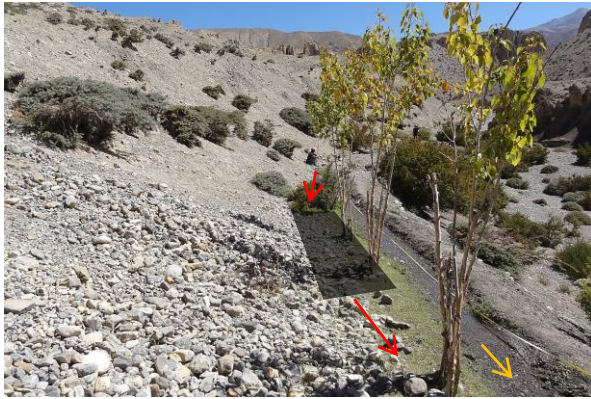
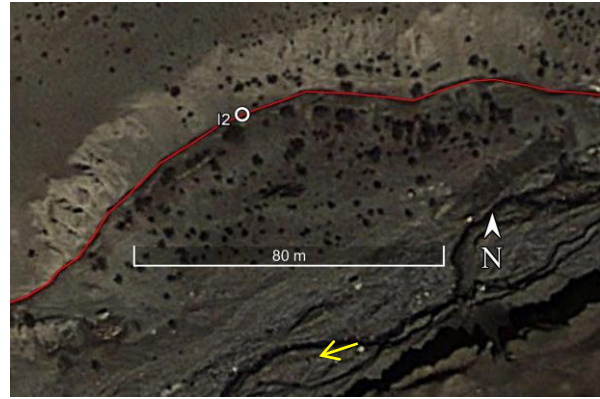
Figure 7.9: Position of the inspection chamber I2 ($x = 388 \text{ m}$; $29^{\circ}05'20.04''\text{N}$ / $84^{\circ}00'32.12''\text{E}$). **Left:** The pipeline (red arrows) and the chamber (black rectangle) are proposed to be shifted slightly inwards to be at a safe distance from the instable slope downhill. The open, earthen channel is highlighted by the orange arrow (photo: 27/09/2013, Daniel Bernet). **Right:** Bird's eye view of the inspection chamber's location. The red line indicates the pipeline and the yellow arrow points in Puyung Khola's flow direction (source: Google Earth Pro, accessed 30/01/2014).

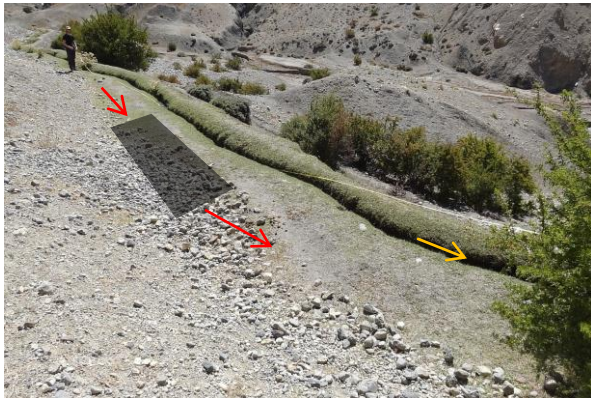
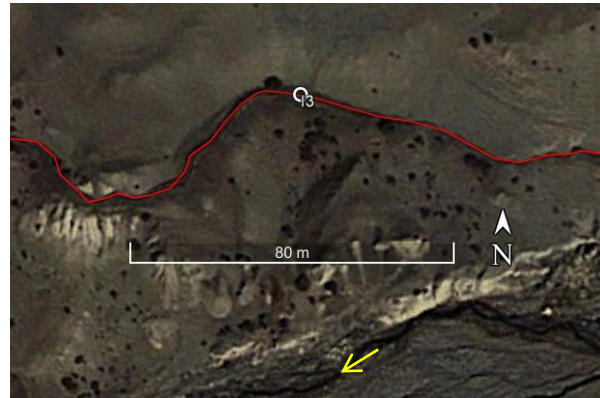
Figure 7.10: Position of the inspection chamber I3 ($x = 564 \text{ m}$; $29^{\circ}05'18.76''\text{N}$ / $84^{\circ}00'26.47''\text{E}$). **Left:** The pipeline (red arrows) and the chamber (black rectangle) are proposed to be shifted slightly inwards to be at a safe distance from the instable slope downhill. The open, earthen channel is highlighted by the orange arrow (photo: 27/09/2013, Daniel Bernet). **Right:** Bird's eye view of the inspection chamber's location. The red line indicates the pipeline and the yellow arrow points in Puyung Khola's flow direction (source: Google Earth Pro, accessed 30/01/2014).

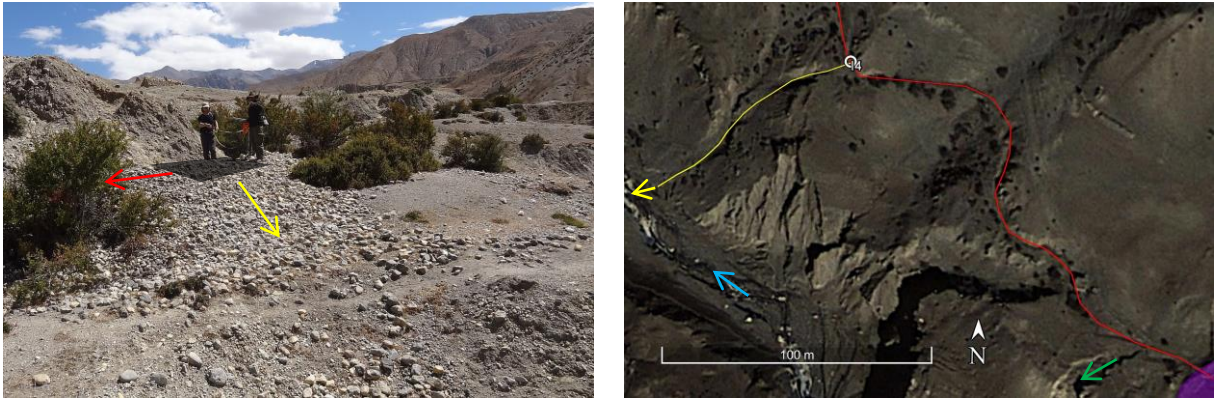
C.1 Inspection chamber

Figure 7.11: Position of the inspection chamber I4 ($x = 959$ m; $29^{\circ}05'24.08''N$ / $84^{\circ}00'16.40''E$). **Left:** The pipeline (red arrow) and the chamber (black rectangle) are proposed to be located at the illustrated position (photo: 27/09/2013, Daniel Bernet). **Right:** Bird's eye view of the inspection chamber's location. The red line indicates the pipeline, the yellow line highlights the routing of the flush pipe (Figure 7.11), the blue arrow points in the river's flow direction and the green arrow indicates the backward erosion caused by diverting water from the reservoir (violet area) to the river (source: Google Earth Pro, accessed 30/01/2014).

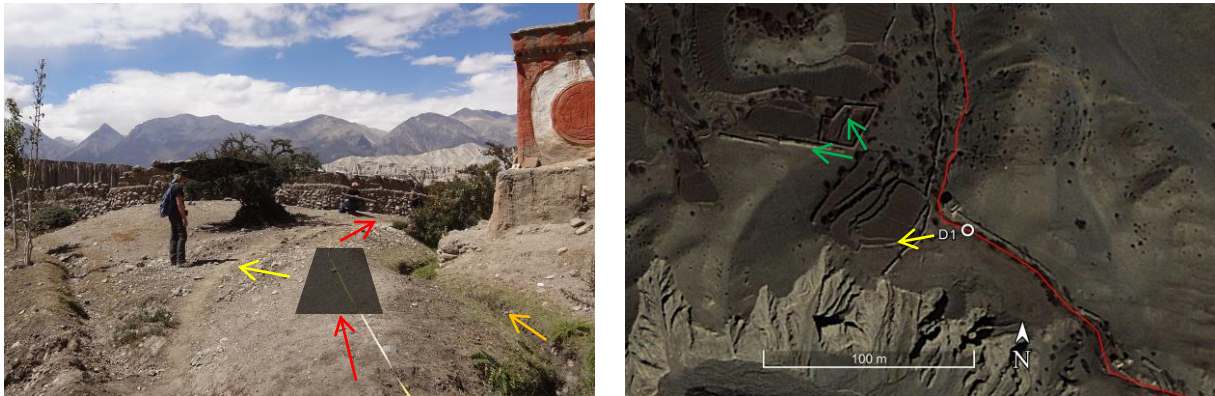
Figure 7.13: Position of the distribution chamber D1 ($x = 1292 \text{ m}$; $29^{\circ}05'31.07''\text{N}$ / $84^{\circ}00'09.08''\text{E}$). **Left:** The pipeline (red arrow) and the chamber (black rectangle) are proposed to be located just next to the open distribution channel, indicated by the orange arrow (photo: 27/09/2013, Daniel Bernet). **Right:** Bird's eye view of the inspection chamber's location. The red line indicates the pipeline, the yellow arrow highlights where the chamber's diversion pipe should meet the open channel network to distribute the water to the corresponding field area, indicated by the green arrows (source: Google Earth Pro, accessed 30/01/2014).

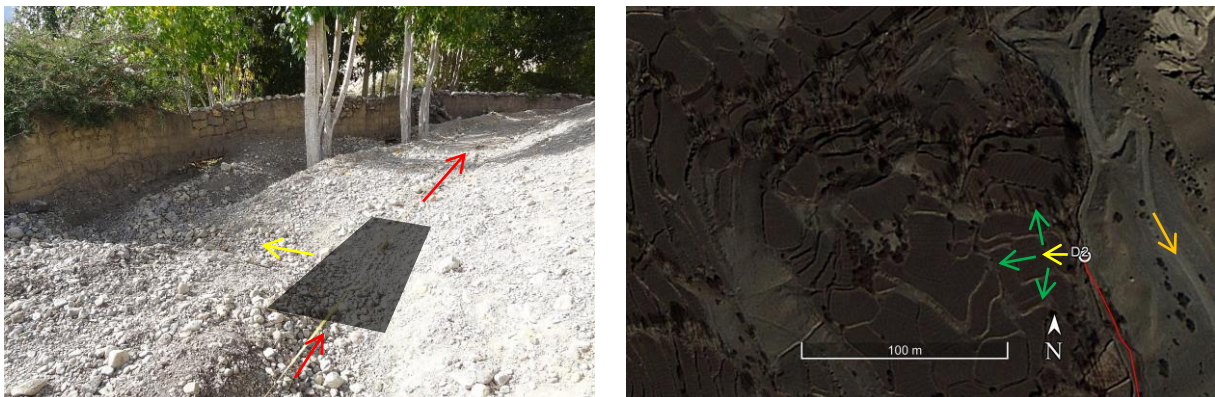
Figure 7.14: Position of the distribution chamber D2 ($x = 1475 \text{ m}$; $29^{\circ}05'36.57''\text{N}$ / $84^{\circ}00'07.71''\text{E}$). **Left:** The pipeline (red arrow) and the chamber (black rectangle) are proposed to be located at the illustrated position (photo: 27/09/2013, Daniel Bernet). **Right:** Bird's eye view of the inspection chamber's location. The red line indicates the pipeline, the yellow arrow highlights where the chamber's diversion pipe should meet the open channel network to distribute the water to the corresponding field area (green arrows). The path leading to Ghara is highlighted by an orange arrow (source: Google Earth Pro, accessed 30/01/2014).

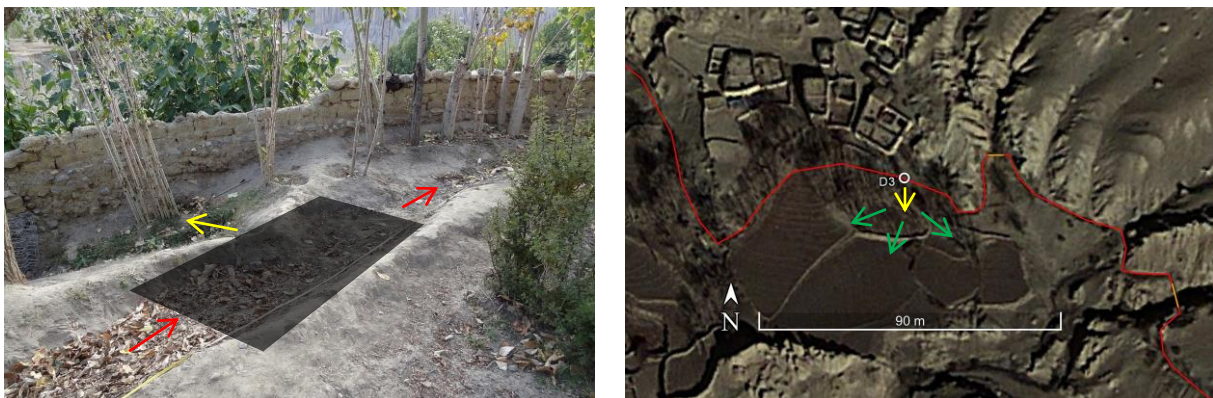
D.2 Distribution chamber

Figure 7.20: Position of the distribution chamber D3 ($x = 1882$ m; $29^{\circ}05'44.51''N / 84^{\circ}00'03.79''E$). **Left:** The pipeline (red arrow) and the chamber (black rectangle) are proposed to be located on top of the open distribution channel (photo: 27/09/2013, Daniel Bernet). **Right:** Bird's eye view of the inspection chamber's location. The red line indicates the pipeline with gully crossings (orange sections), the yellow arrow highlights where the chamber's diversion pipe should meet the open channel network to distribute the water to the corresponding field area indicated by the green arrows (source: Google Earth Pro, accessed 30/01/2014).

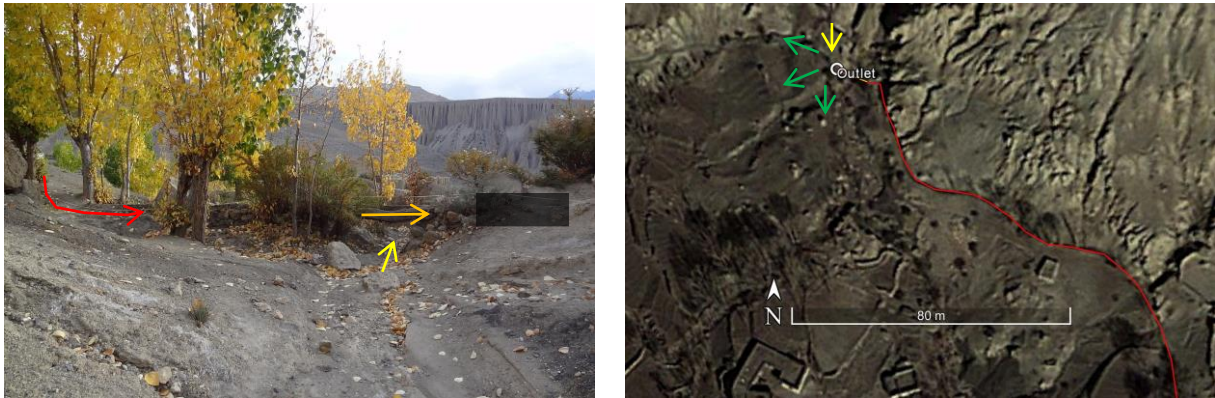
D.3 Outlet structure

Figure 7.21: Position of the irrigation water supply pipeline's outlet ($x = 2134$ m; $29^{\circ}05'47.49''N$ / $83^{\circ}59'57.83''E$). **Left:** The pipeline (red arrow) crosses the gully (yellow arrow) supported by a wooden bar (orange arrow) and merges into the outlet structure, indicated by the black rectangle (photo: 27/09/2013, Daniel Bernet). **Right:** Bird's eye view of the outlet's location. The red line indicates the pipeline and the yellow arrow the gully, which has to be crossed just before the pipeline ends. From the outlet, the water can be brought to the corresponding fields by the open channel network indicated by the green arrows (source: Google Earth Pro, accessed 30/01/2014).
